Report of findings from archaeological investigation at RAF Wartling
World War II domestic camp site within the Herstmonceux Castle
Estate, East Sussex, BN27 1RN

Site Code: HCRAF-22

Prepared by Meghan E. Strong, PhD
Archaeology Field School Instructor
June 2022

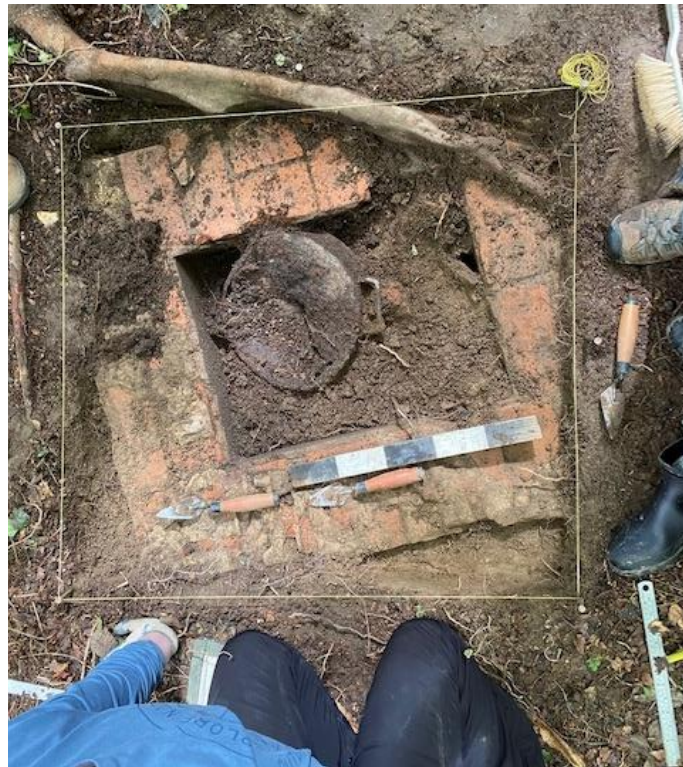
Level 4 (6-10 cm) - Level 5 (10-15 cm): An extension of the brick structure (Context 1001) along the Southern border was uncovered. It was thus established that the brick structure was completely enclosed, comprising four walls rather than a three-walled enclosure. Excavation on the fill of the pit (Context 1002) began at Level 5 (Figure 2).

*Figure 2 - Photo of test pit 1 at Level 4 with upturned cooking pot in situ
(Photo: Meave Mooney)*

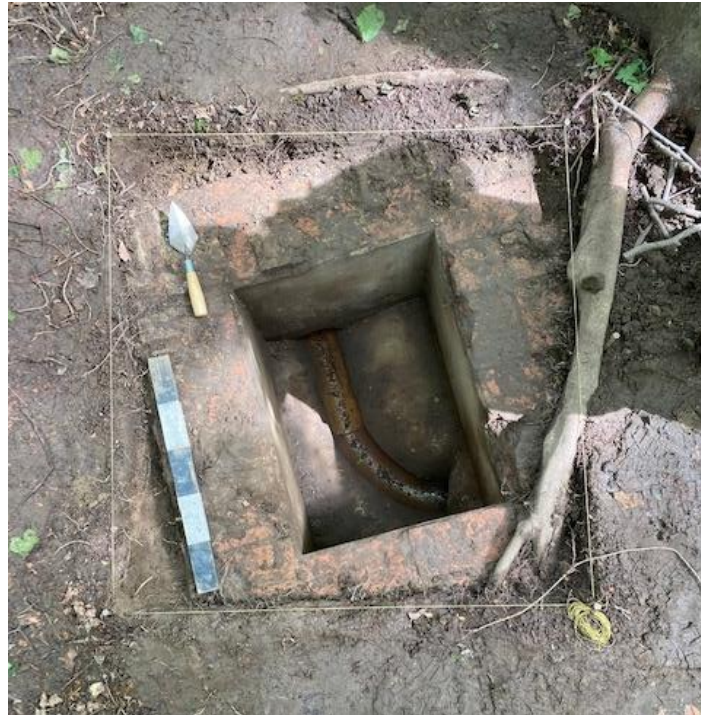
Level 7 (55-68cm): In this level, the fourth and final piece of the metal grate (small find 1002-7) was unearthed. In addition, the bottom of the brick structure was reached - unveiling sloped, concrete walls and a salt-glazed ceramic channel (Context 1003) running through the centre of the brick-lined pit. The channel stretched from the southernmost corner of the east wall, arching to flow directly into the centre of the north wall (Figure 3). Backfilled on May 26, 2022.

Figure 3 - Bottom of test pit 1 with ceramic-lined channel visible (Photo: Meave Mooney)

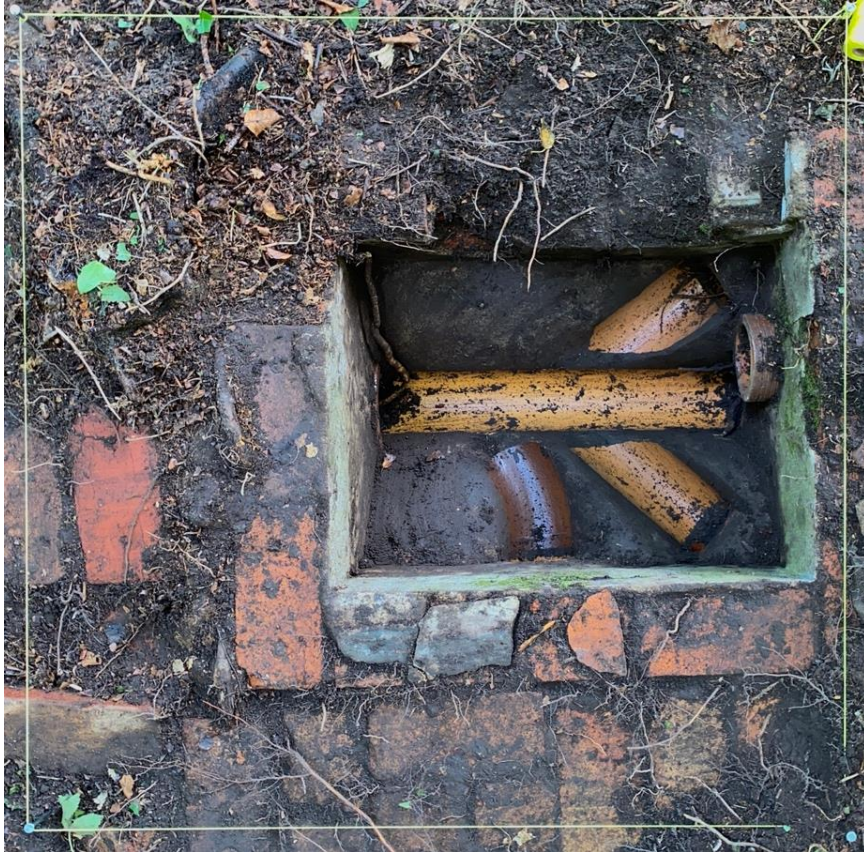
This test pit was opened on May 24, 2022. It was discovered that morning, after the Herstmonceux Castle's landscaping team had cleared the area of underbrush and brambles. It is located south of the bridle path, and just west of the walking path that runs along Wartling Road. It is the easternmost test pit of the grouping of test pits 3, 4, and 5. The location of test pit 3 was chosen because of an area of exposed brickwork on the surface, which surrounded a visible shaft cut into the ground. When clearance began, the pit was filled in with soil and brick fragments. In order to leave the brickwork intact, only the shaft was excavated (Context 3001). Surface dirt and plant material was cleared to define the brickwork for photos and drawing (Figure 4).

Figure 4 - Overview of test pit 3 with surrounding brick on surface (Photo: Clare McMullen)

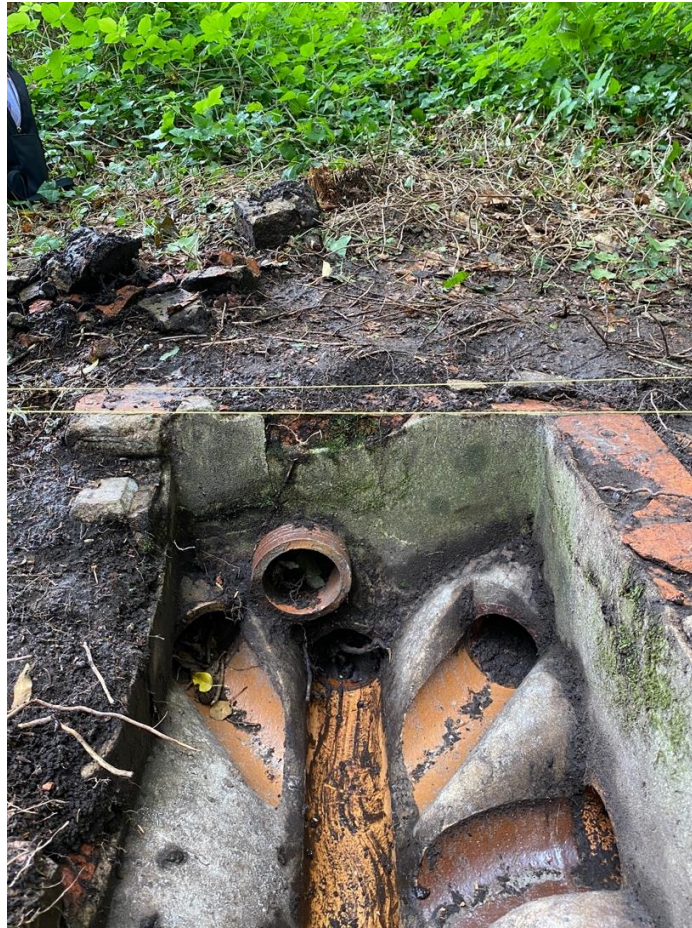
The interior of the concrete-lined shaft was filled with loose topsoil that appears to have been naturally deposited; no stratigraphy was identified. Fragments of brick, as well as blue-painted wall debris were mixed throughout the fill. At approximately 10 cm depth, the first of a series of pipes (Contexts 3002 – 3006) were identified in the east wall of the shaft. Between 10 – 15 cm depth, two more pipe-lined channels were found emerging from the northeast and southeast corners of the shaft, as well as a darker brown pipe-lined channel emerging from the south side of the shaft (Figure 5). Finally, a central pipe was uncovered, at 23 cm depth, running from the east to the west side of the shaft, and to which the other three pipe-lined channels connected. In between all of the pipes and pipe-lined channels were mounds of concrete. The central pipe was the lowest and we concluded that this shaft contained a junction for pipes that flow westward. The pipes seem to be made of salt-glazed ceramic and

match the pipes found in test pits 4 and 5, as well as other pipe fragments found around the site. Backfilled on May 25, 2022.

Figure 5 - Looking east at series of pipes and ceramic-lined channels in test pit 3
(Photo: Clare McMullen)

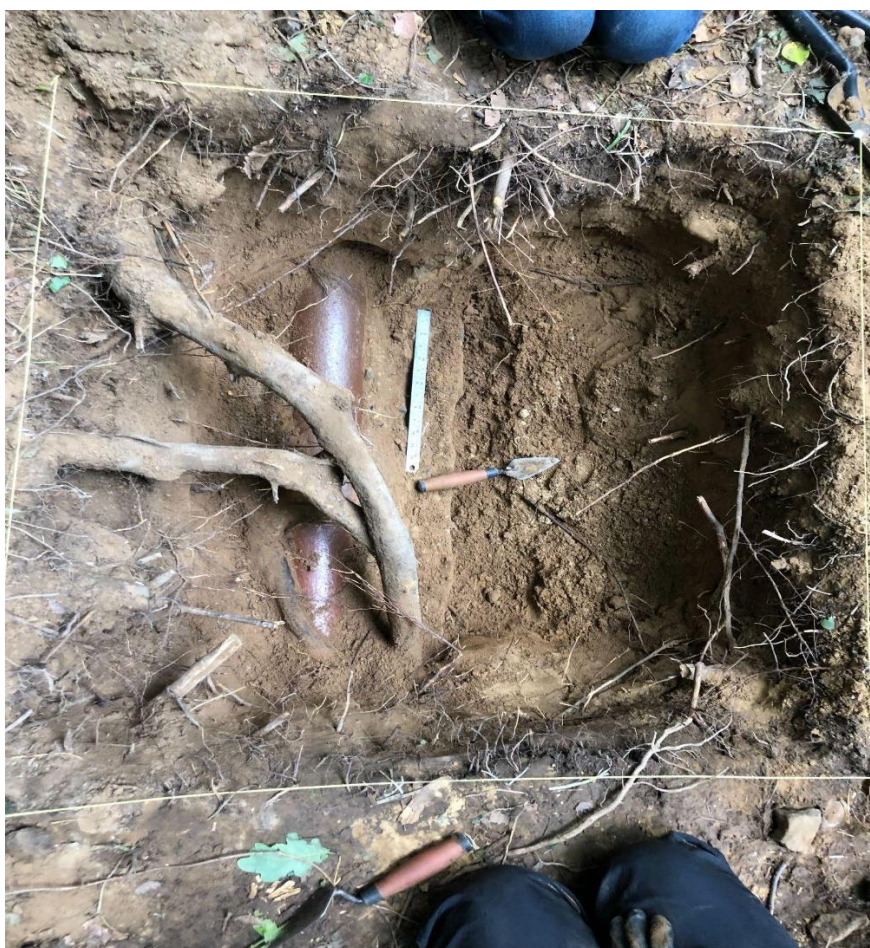
Digging was done in 10 cm layers as any connecting pipe would likely be at least 23 cm deep based on the final depth of test pit 3. The first two layers (0 – 20 cm) were composed of loose top soil and many tree roots. Soil changed to silty clay at approximately 20 cm depth. An intact, salt-glazed ceramic pipe (Context 4001) was uncovered at 38 cm depth running through the center of the test pit from east to west. The pipe was set into a bed of concrete (Context 4002), which could only be cleared on the north side of the pipe due to a thick mass of tree roots on the south side (Figure 6). Backfilled on May 26, 2022.

*Figure 6 - Salt-glazed ceramic pipe in test pit 4 that likely connects test pits 3 and 5
(Photo: John Tsafaridis)*
